Indicative fire test

153505 Issue 3

Environmental Seals

The purpose of the investigation was to provide an indication of the behaviour of a section of a timber floor protected on its underside by a plasterboard ceiling incorporating various types of downlighter, when subjected to its underside to the heating conditions and pressure conditions specified by BS 476: Part 21: 1987.

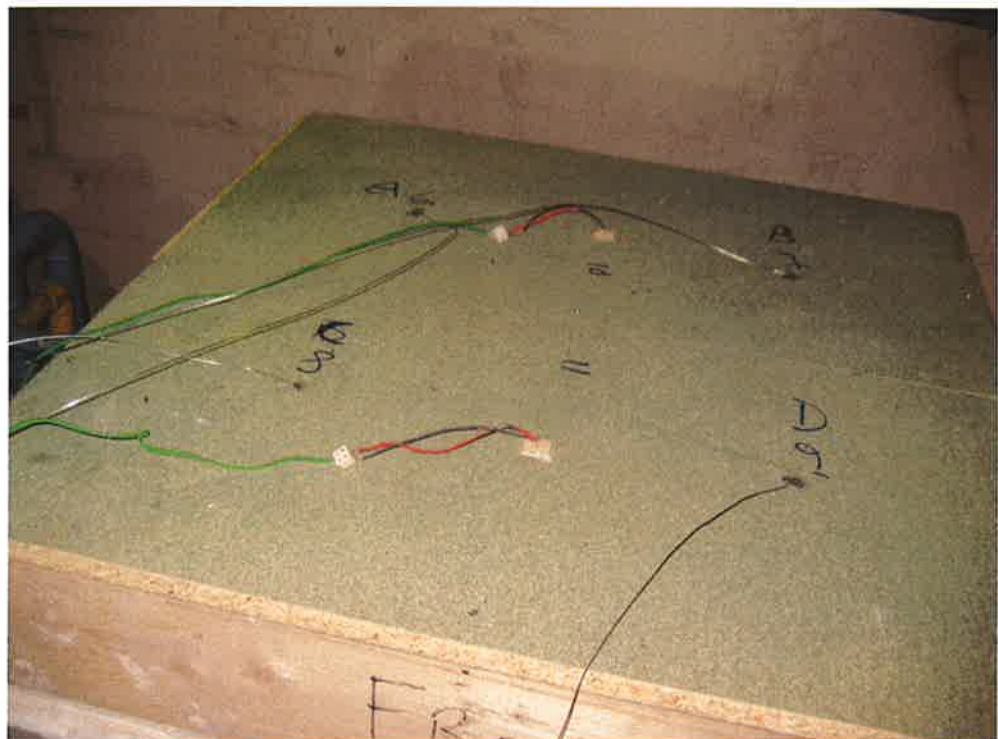
The unexposed surface of the ceiling directly after testing

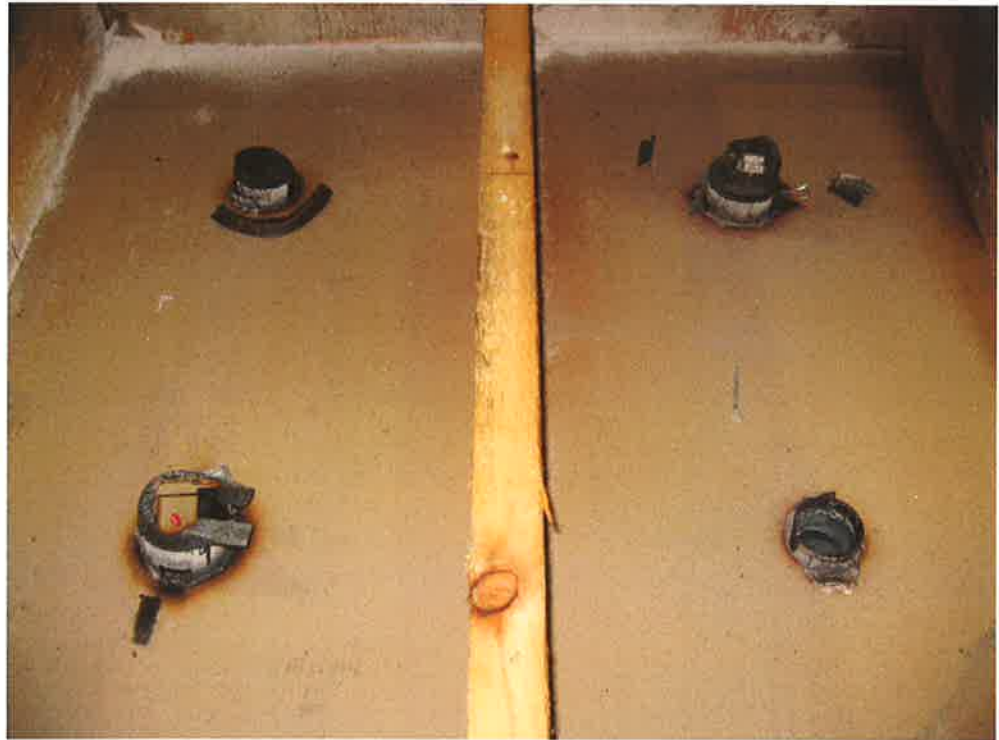
**Showing the
Downlighter
fittings within
the floor cavity
immediately
after testing**

The internal casings to Specimens A, B and C remain in place with charred intumescent filling the voids.
